Annex G

**Swing Bridge
Condition Assessment and Load Rating
2022**

Reference Documents
Swing Bridge Survey Report 2014

**RE: REPORT ON SURVEYING SERVICES IN CONNECTION WITH THE
REMEDIAL WORKS TO SWING BRIDGE, ST. GEORGE, BERMUDA**

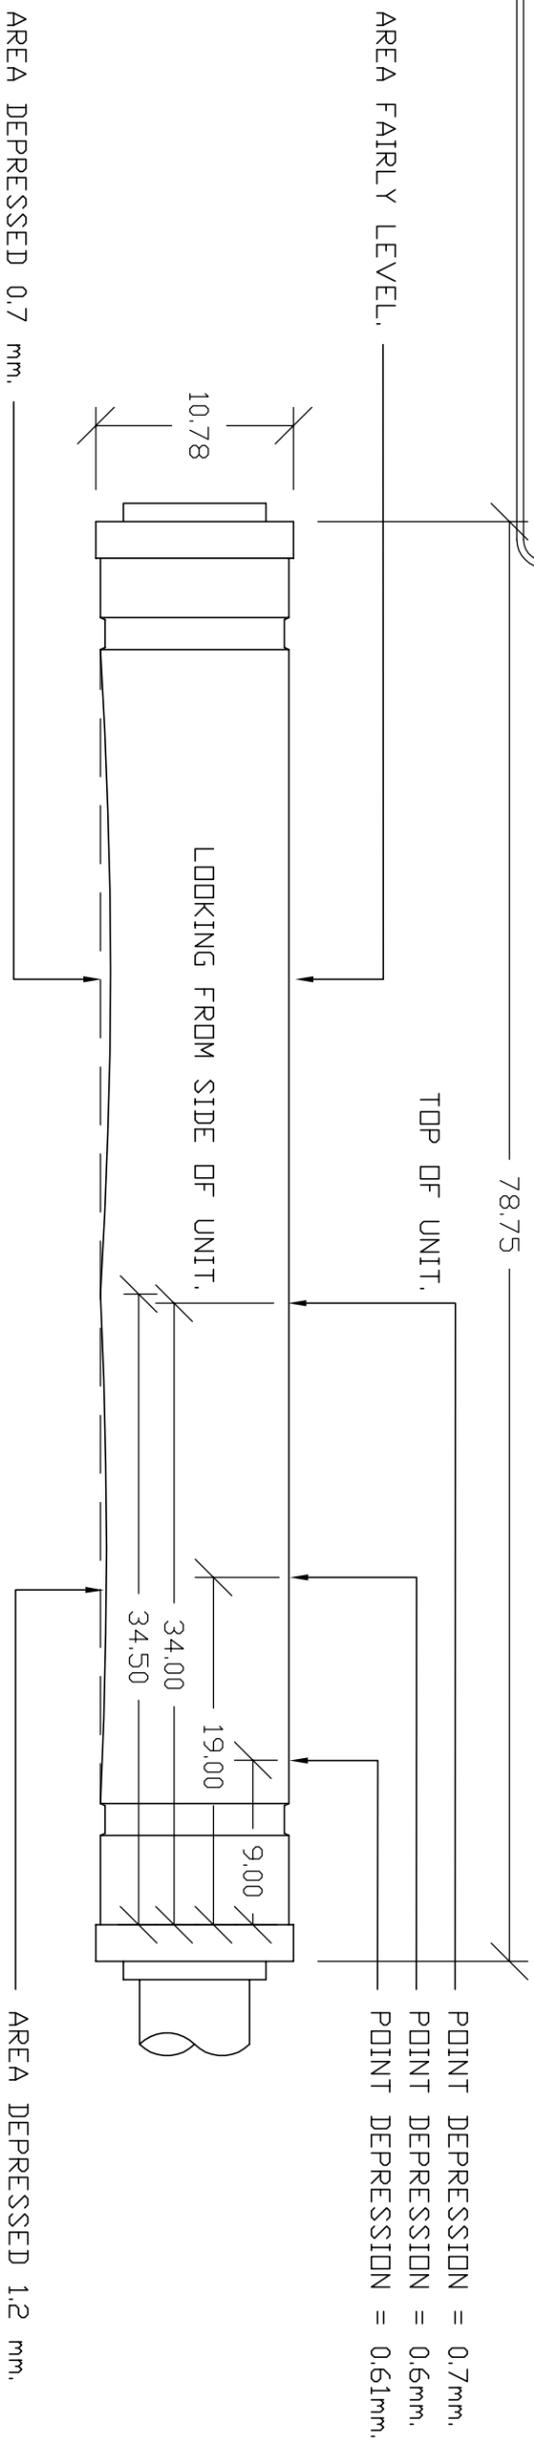
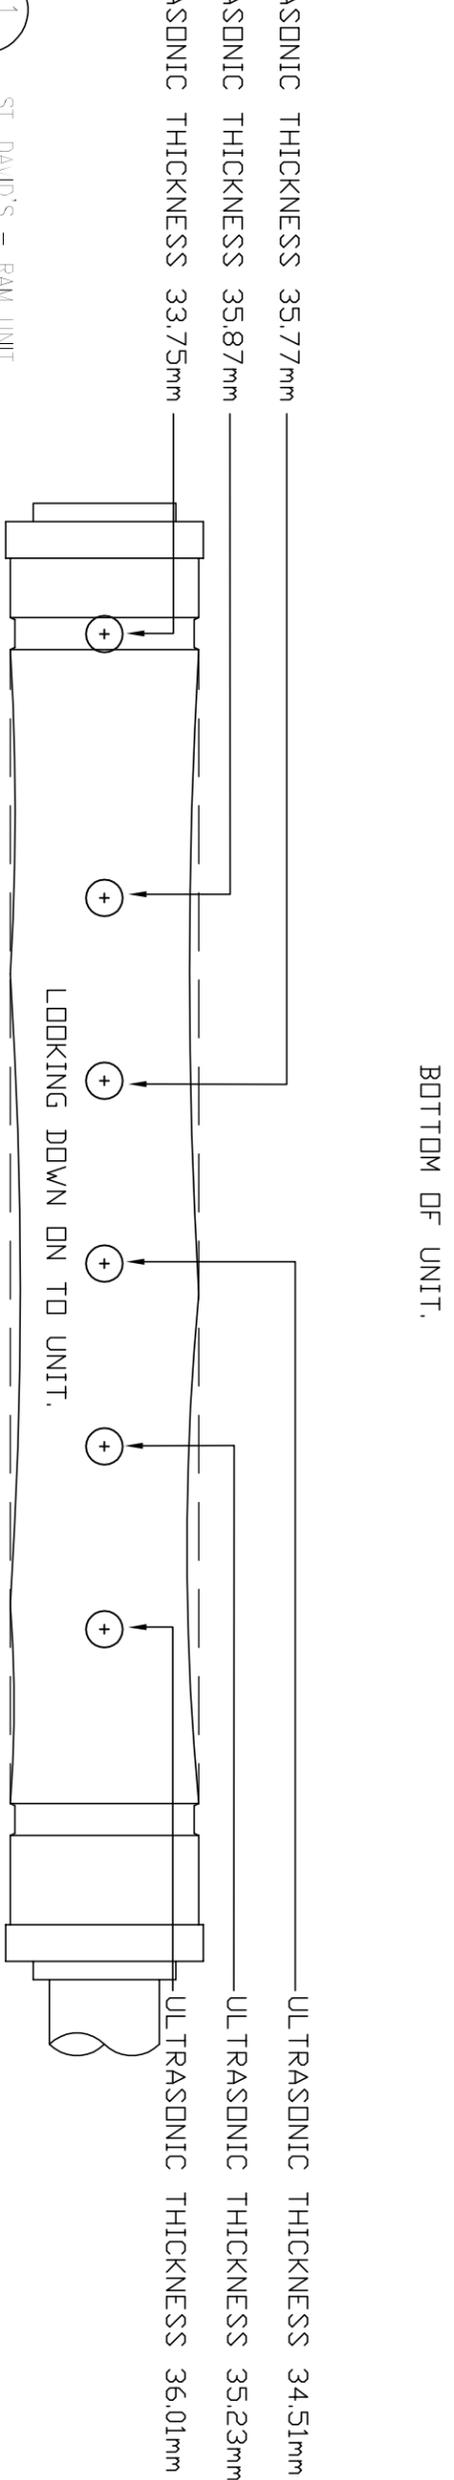
1
 ST. DAVID'S - RAM UNIT
 S002
 1:10

ULTRASONIC THICKNESS 35.77mm
 ULTRASONIC THICKNESS 35.87mm
 ULTRASONIC THICKNESS 33.75mm

POINT DEPRESSION = 0.7mm.
 POINT DEPRESSION = 0.6mm.
 POINT DEPRESSION = 0.61mm.
