Annex G

**Swing Bridge
Condition Assessment and Load Rating
2022**

Reference Documents
Swing Bridge Survey Report 2014

**RE: REPORT ON SURVEYING SERVICES IN CONNECTION WITH THE
REMEDIAL WORKS TO SWING BRIDGE, ST. GEORGE, BERMUDA**

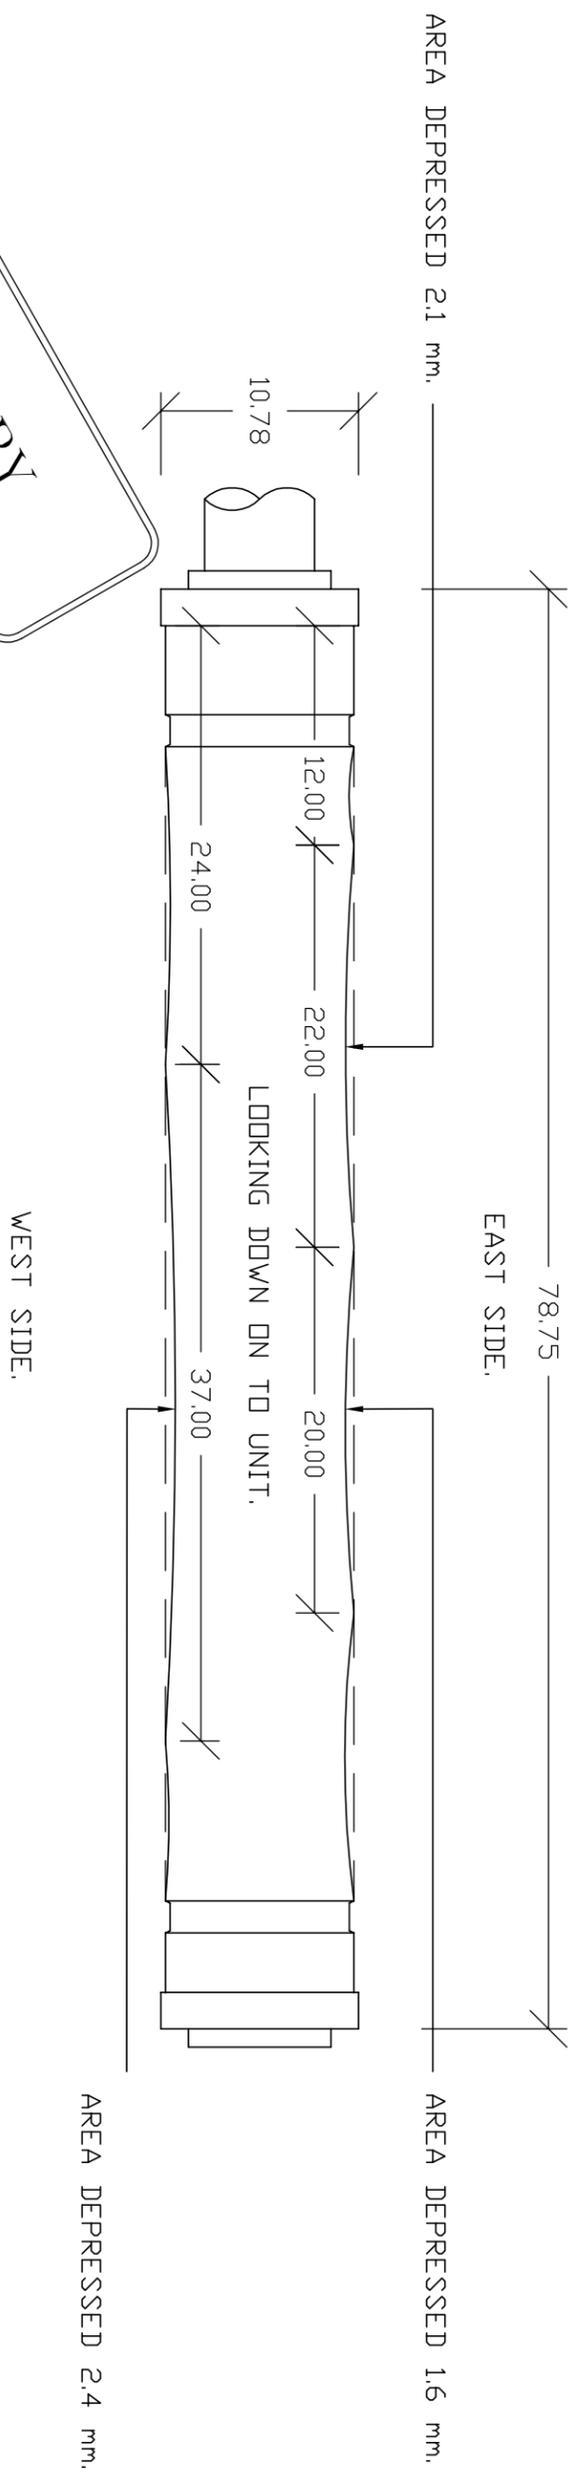
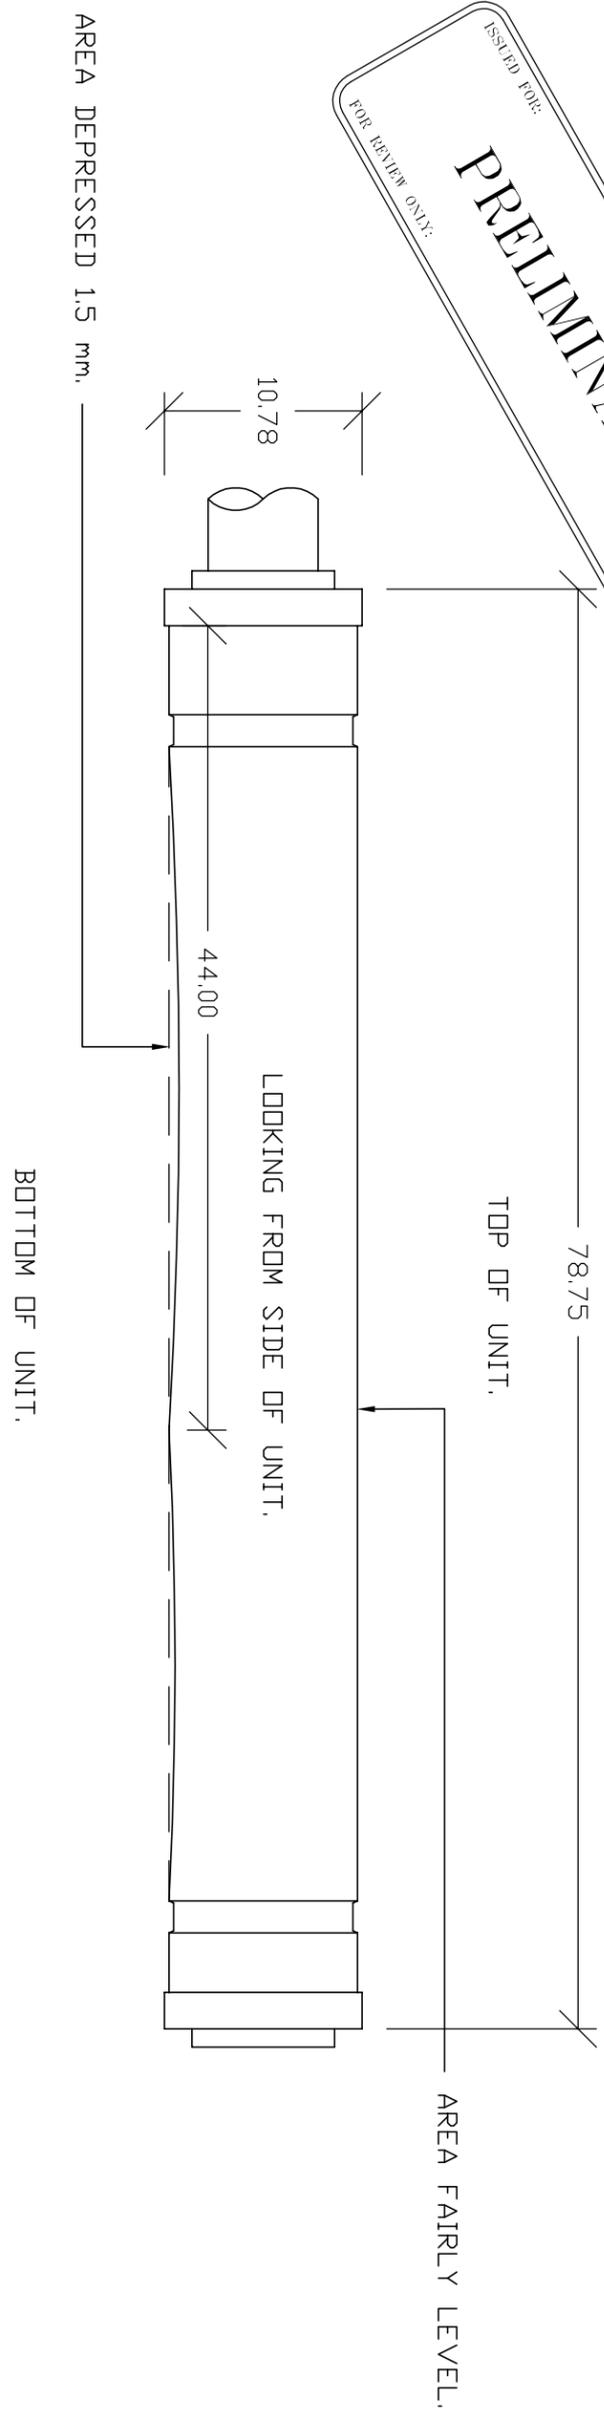
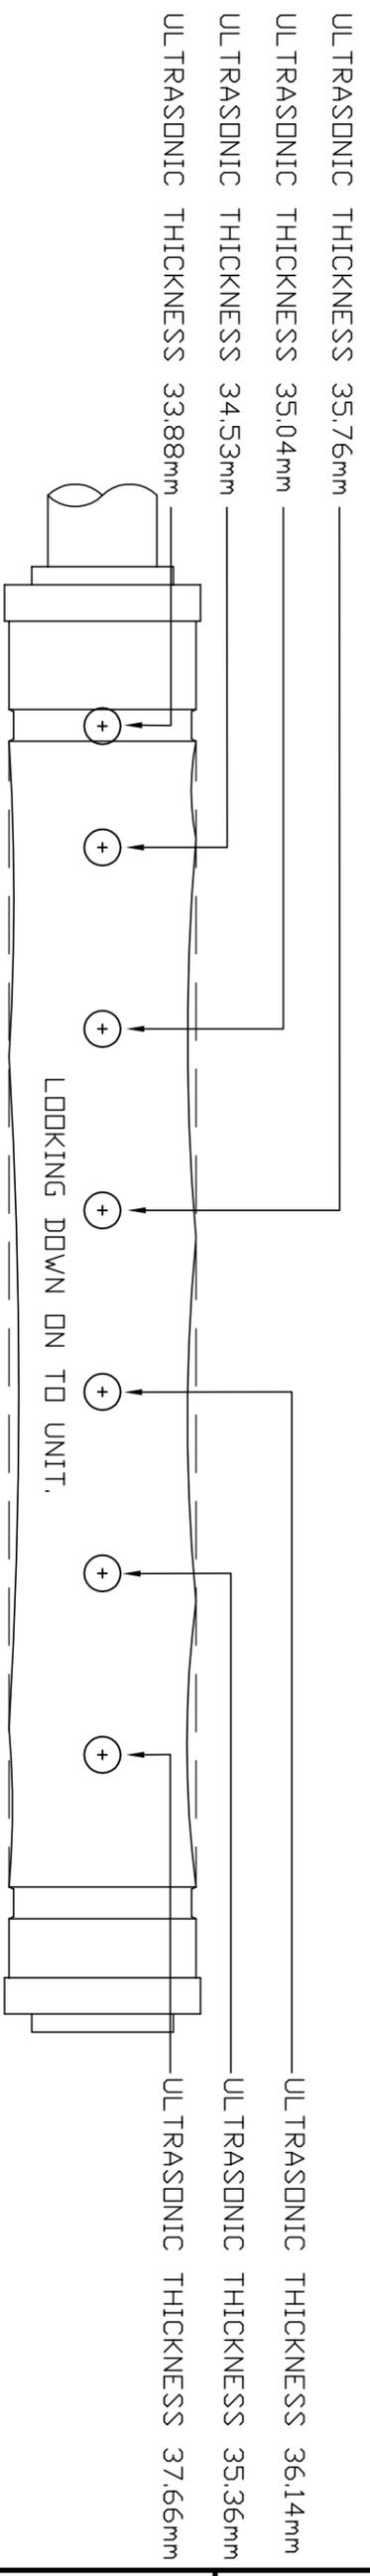
1
ST. GEORGE - RAW UNIT
SC001
1:10

Wedges, rams and plates forming parts of the bridge opening mechanism were measured and details shown on drawings referenced S-001 North Ram Unit, S-002 South Ram Unit, also attached herewith. Measuring wedges and plates still needs to be completed.

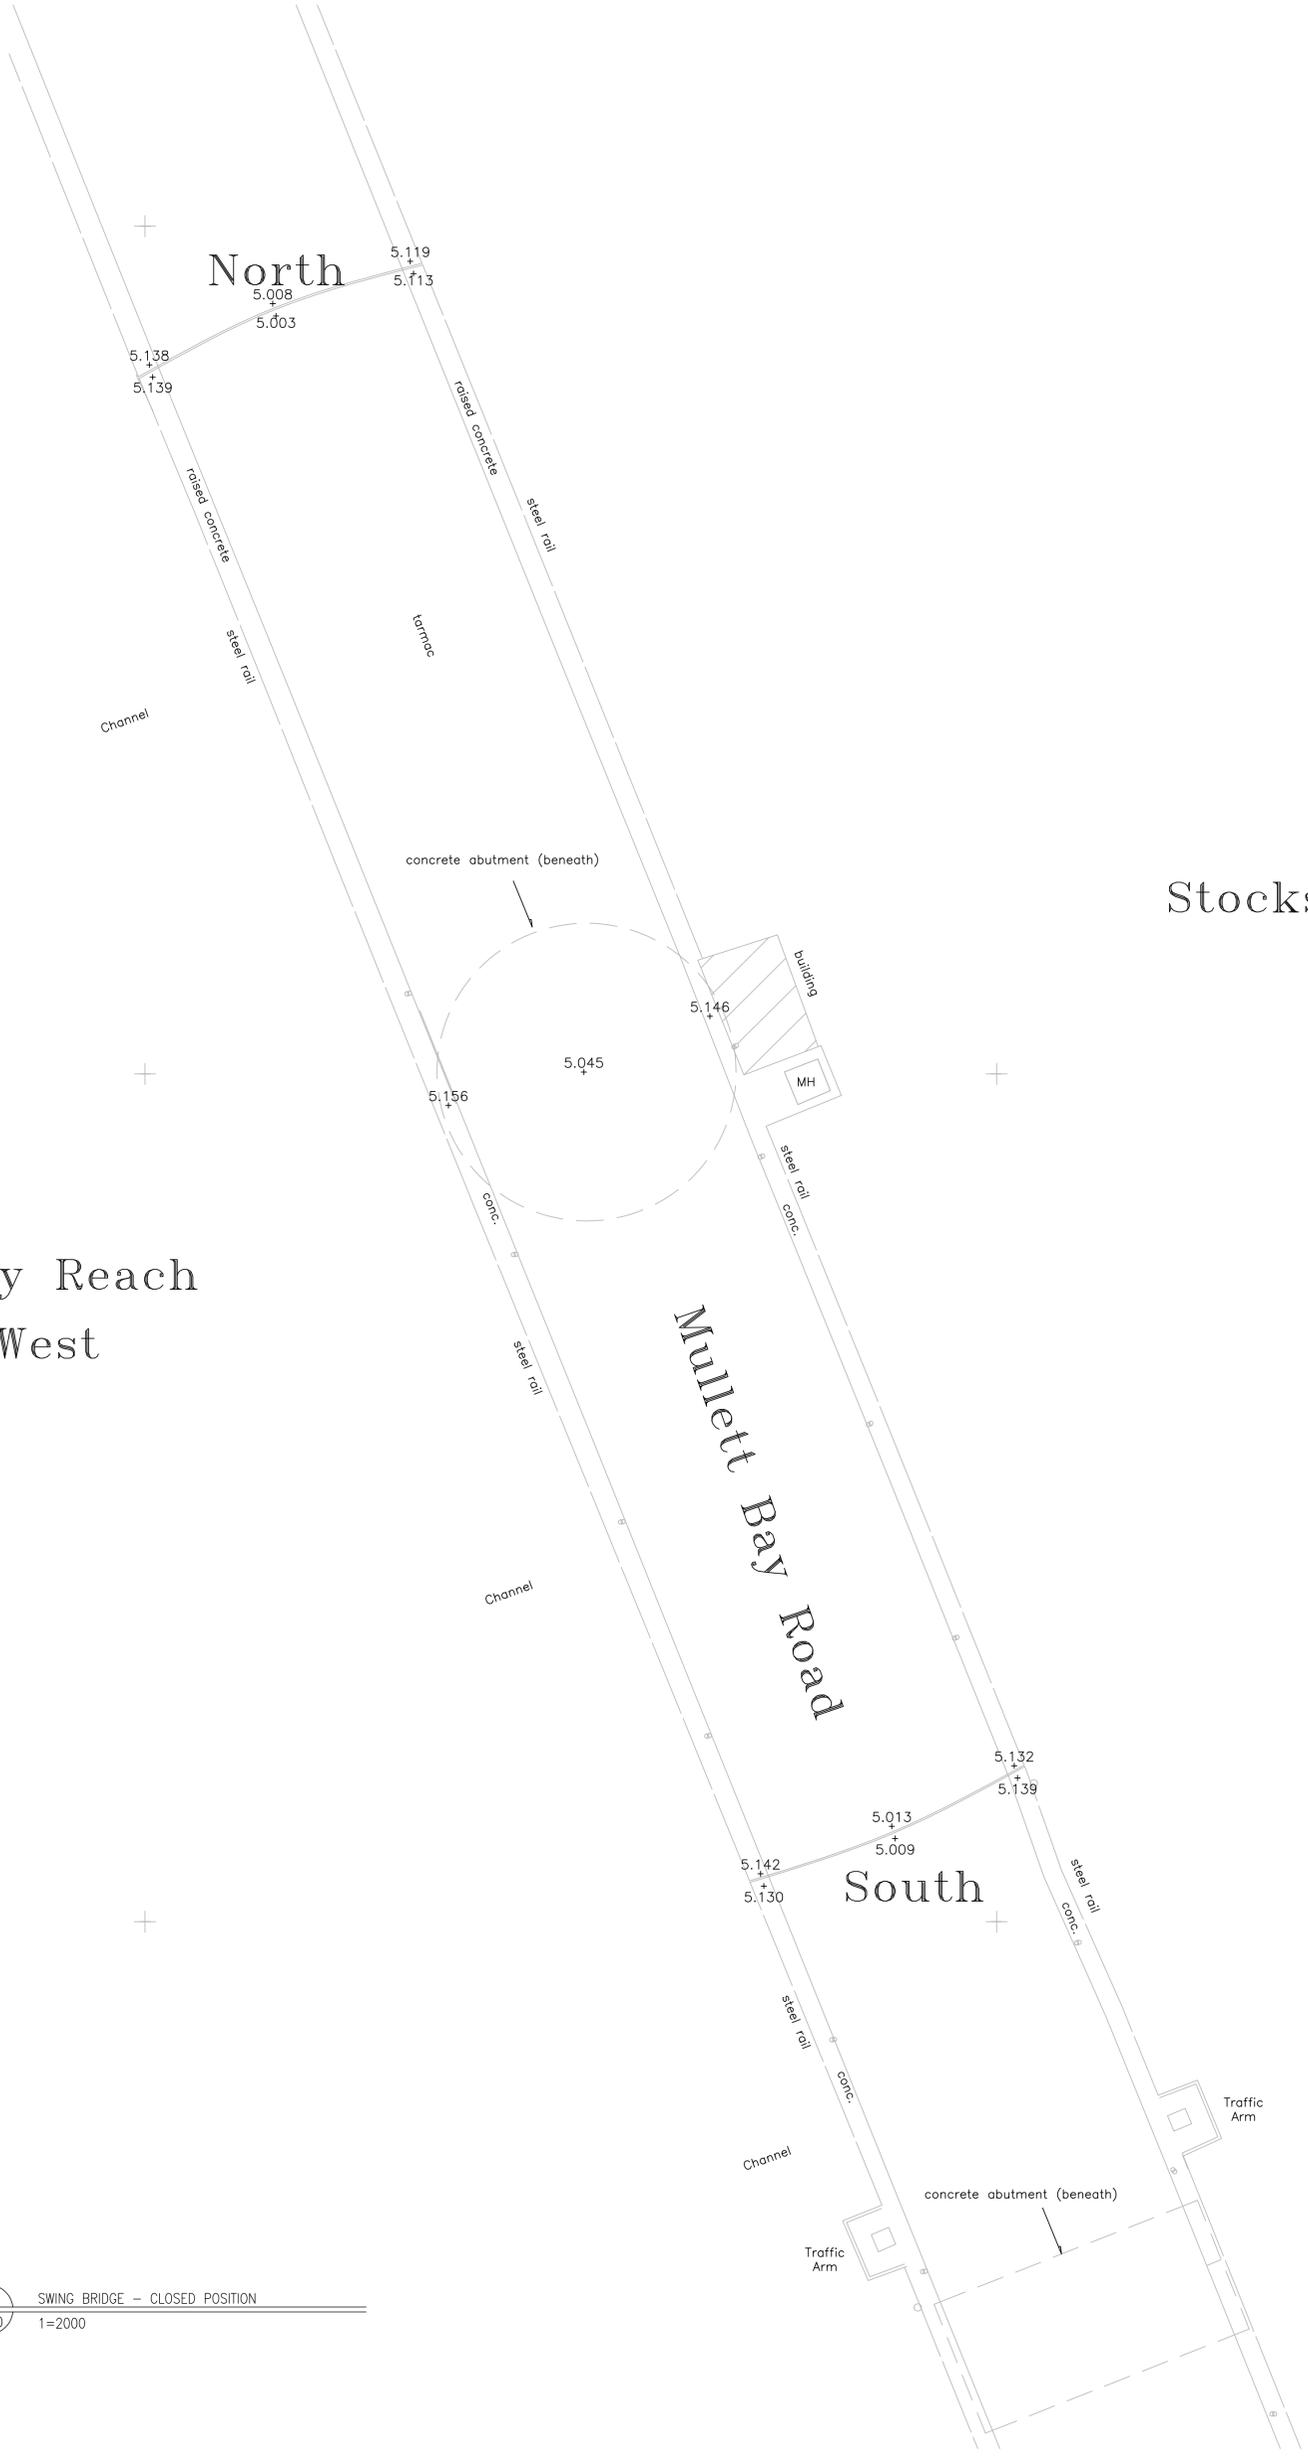
Woodbourne ASSOCIATES LTD P.O. BOX 100 334 HAMILTON, ST. GEORGE, BERMUDA TEL. 441-295-0319 FAX: 441-292-3784			
PROJECT: SWING BRIDGE ST. GEORGE, BERMUDA			
TITLE: SITE ELEVATION & DEFLECTION BRIDGE IN CLOSED POSITION			
NO.	DATE	BY	REVISION
1	APR 22, 16	VR	PRELIMINARY ISSUED FOR REVIEW

Elevations of both ends of the swing span and of the centre points were taken in the closed, partly open and fully open positions. Details of these results are shown on drawings S-100 (closed), S-101 (partly open) and S-102 (fully open), appended.

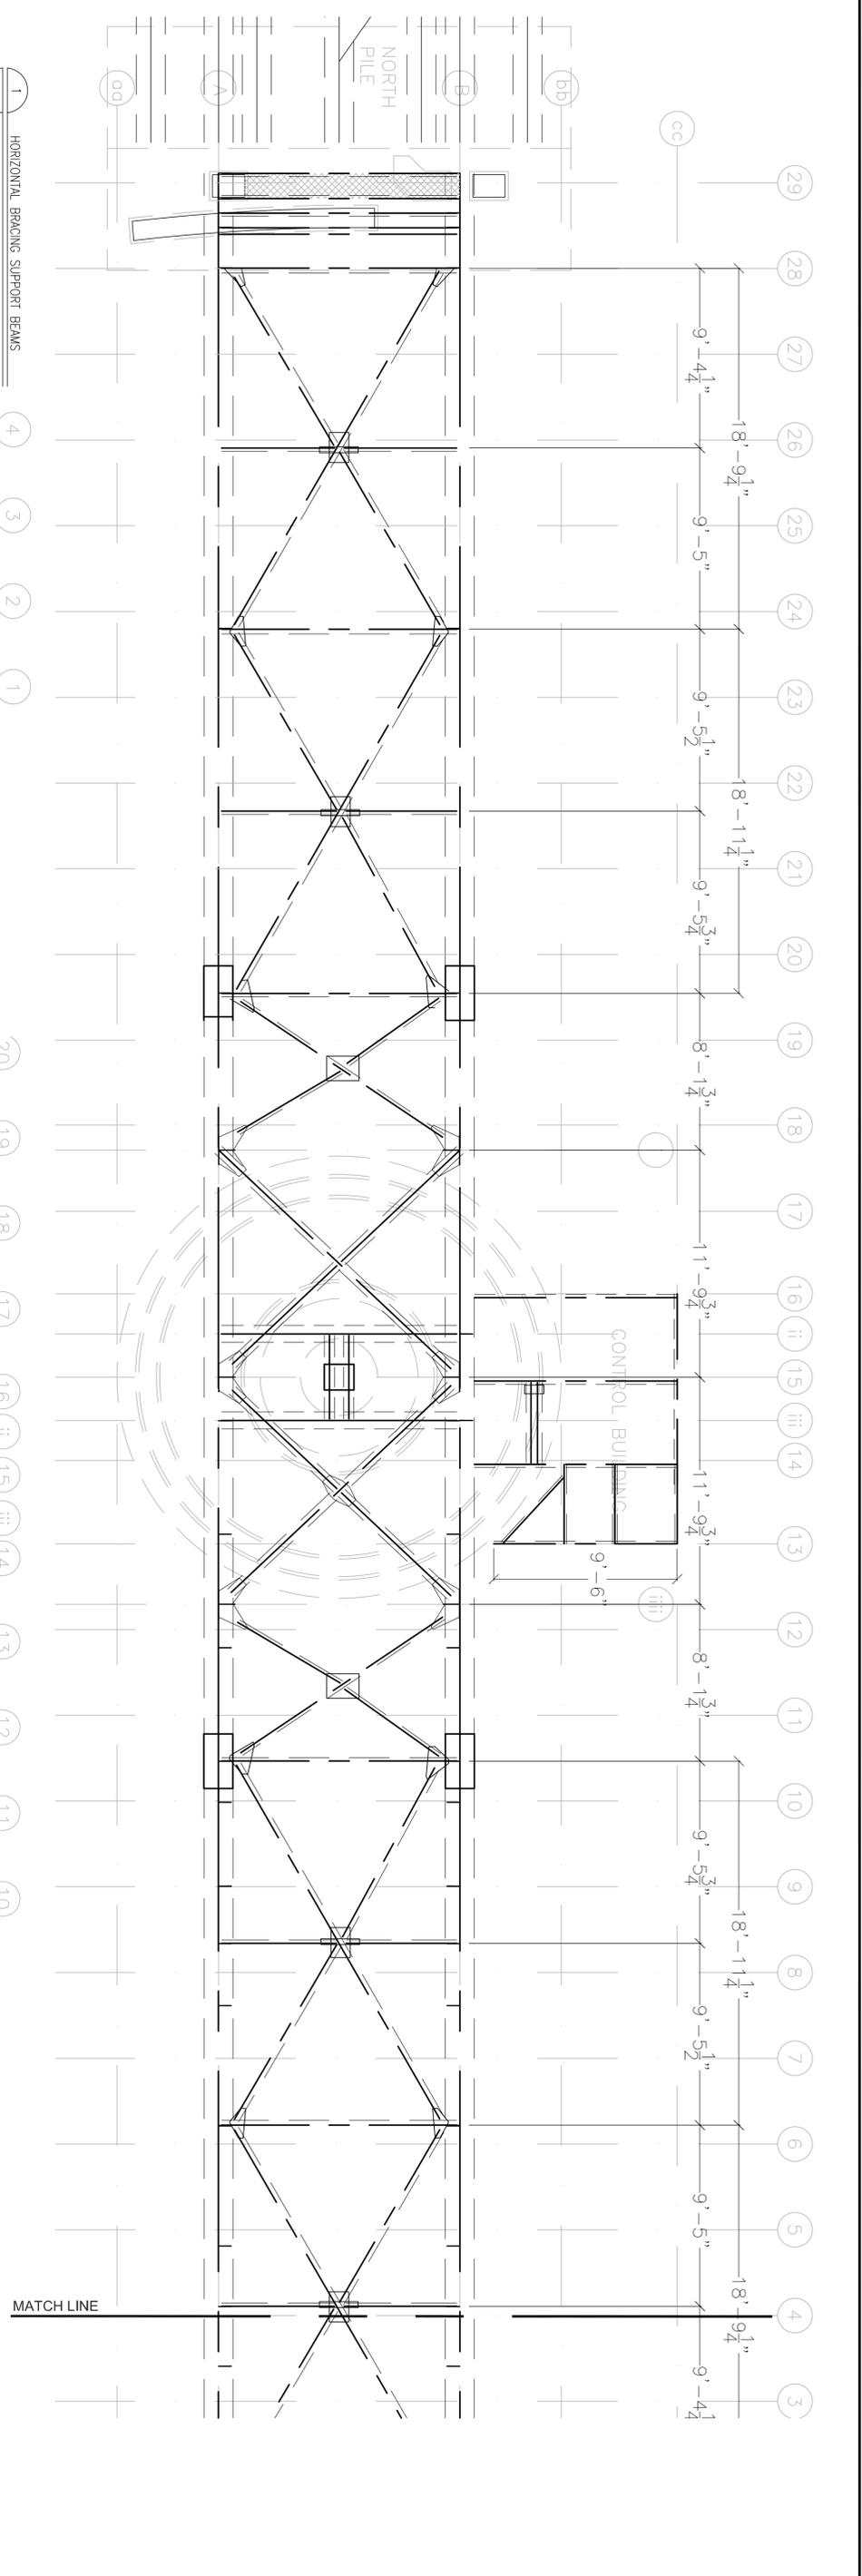
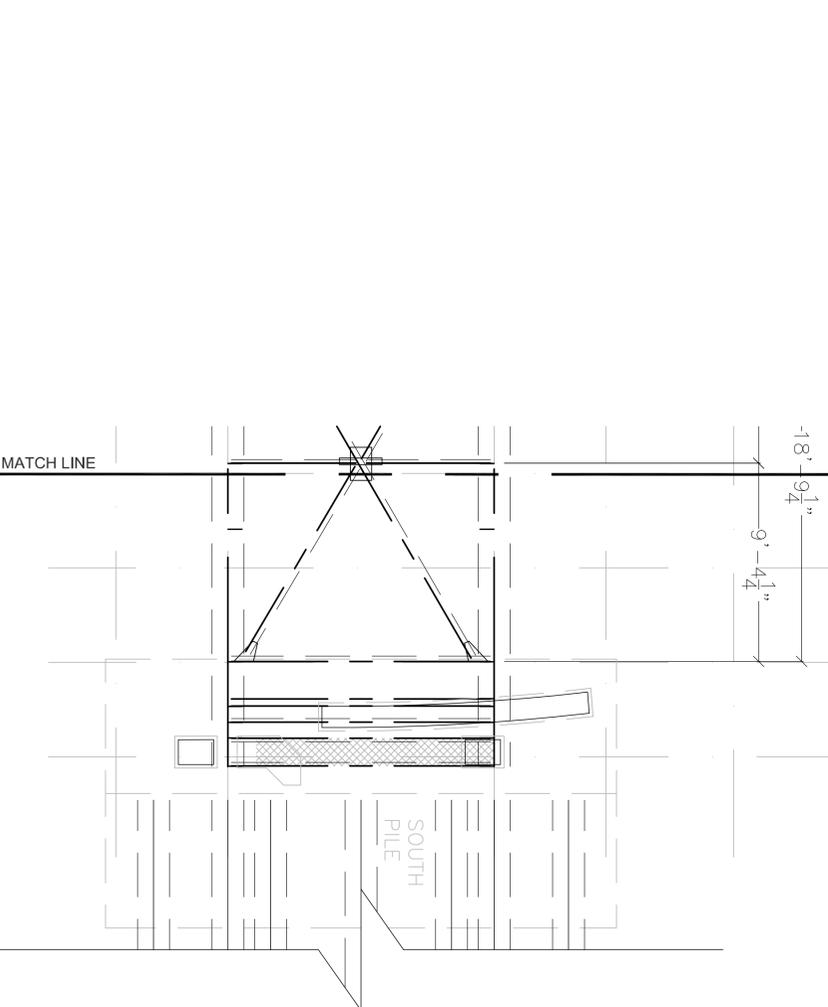
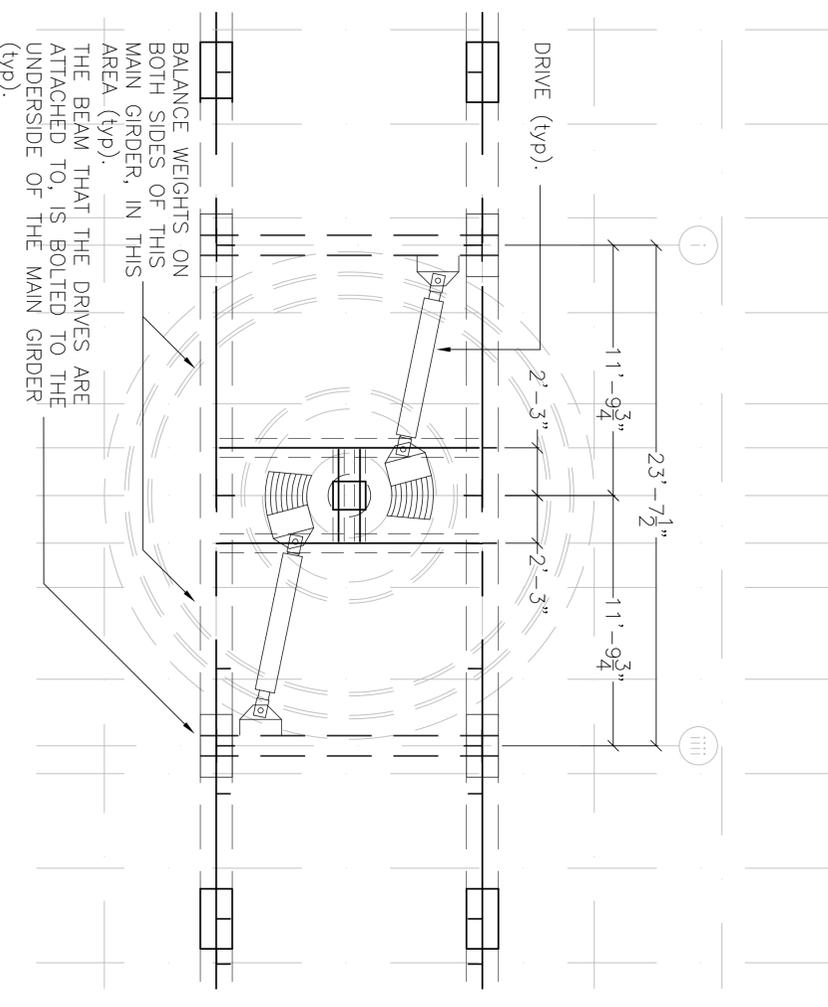
1 HORIZONTAL BRACING SUPPORT BEAMS
S201 1/4" = 1'-0"

Arrangement of horizontal cross-bracing which support the access catwalk under the bridge are shown on drawing S.201
